Mission Concepcion Dome Stabilization - Project Update - March 17, 2020

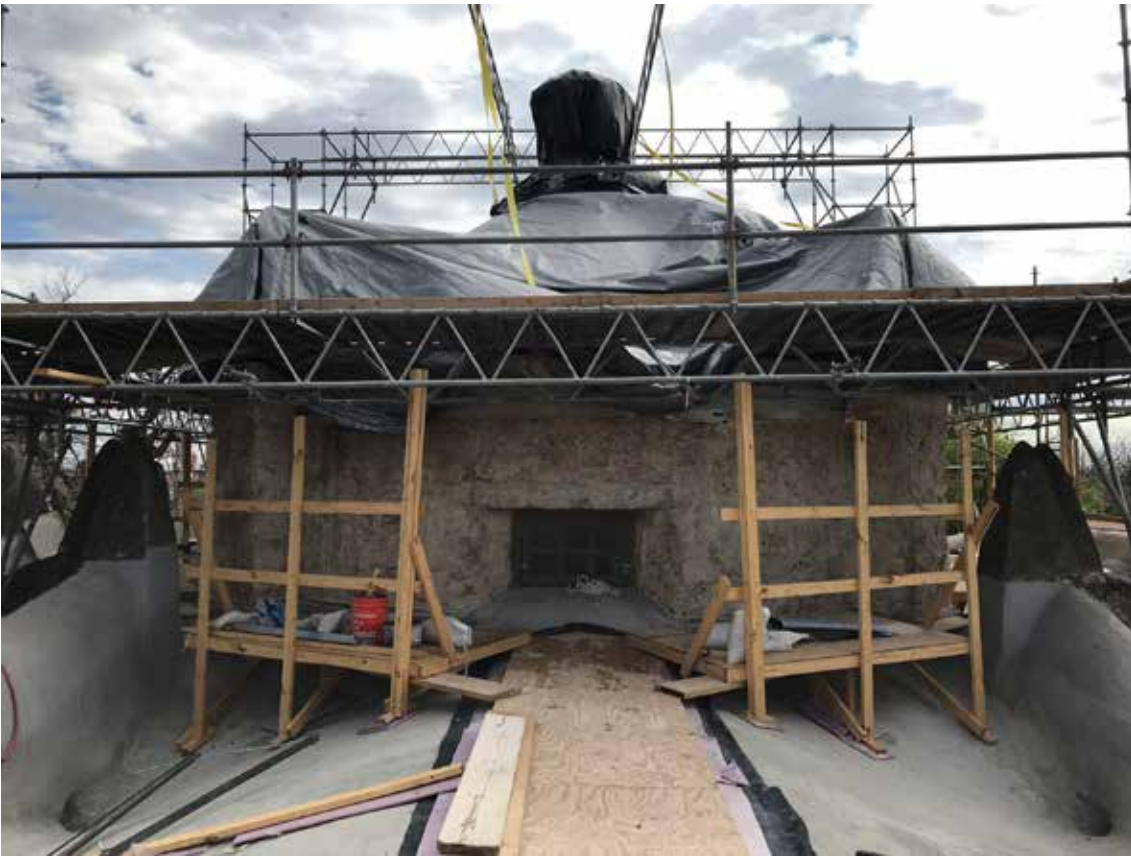
View of west elevation, showing exposed masonry at drum (03.04.2020)

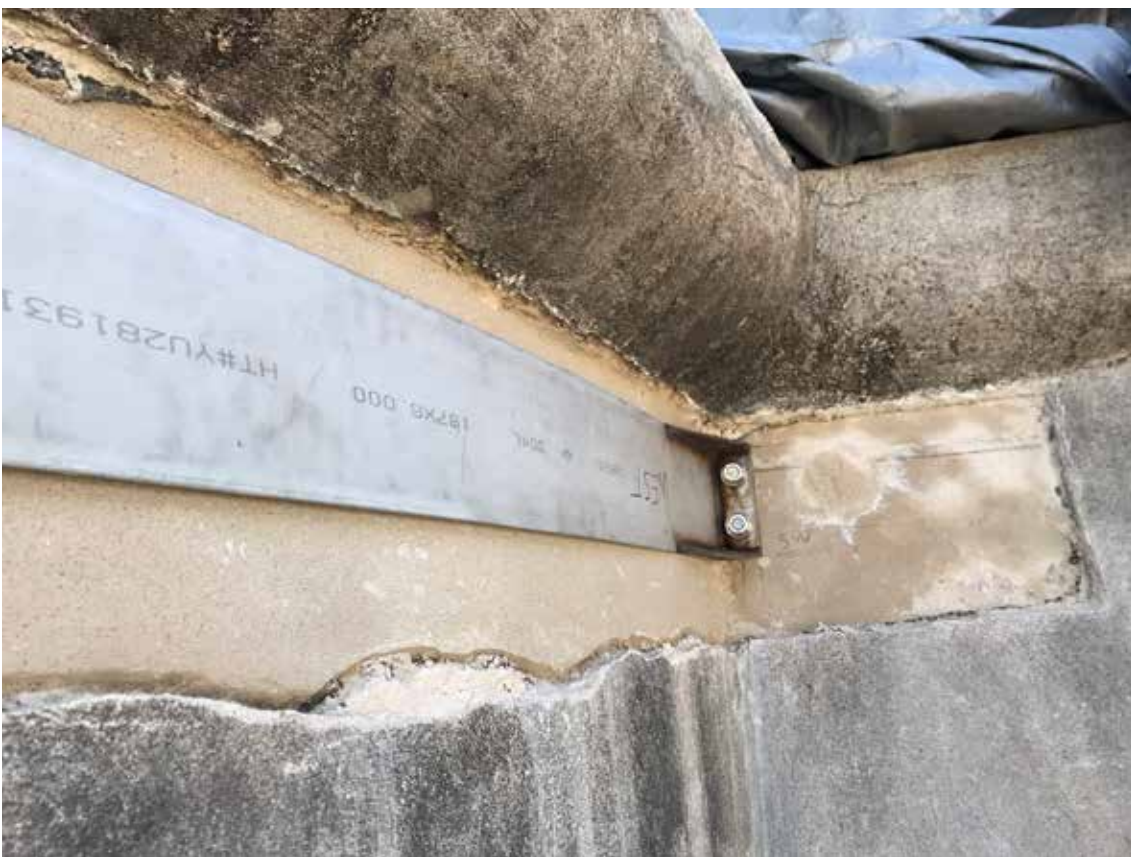
Detail of steel tension band during test fit. Underneath band is a lime plaster "isolation layer" to protect historic mortar and masonry (02.25.2020)

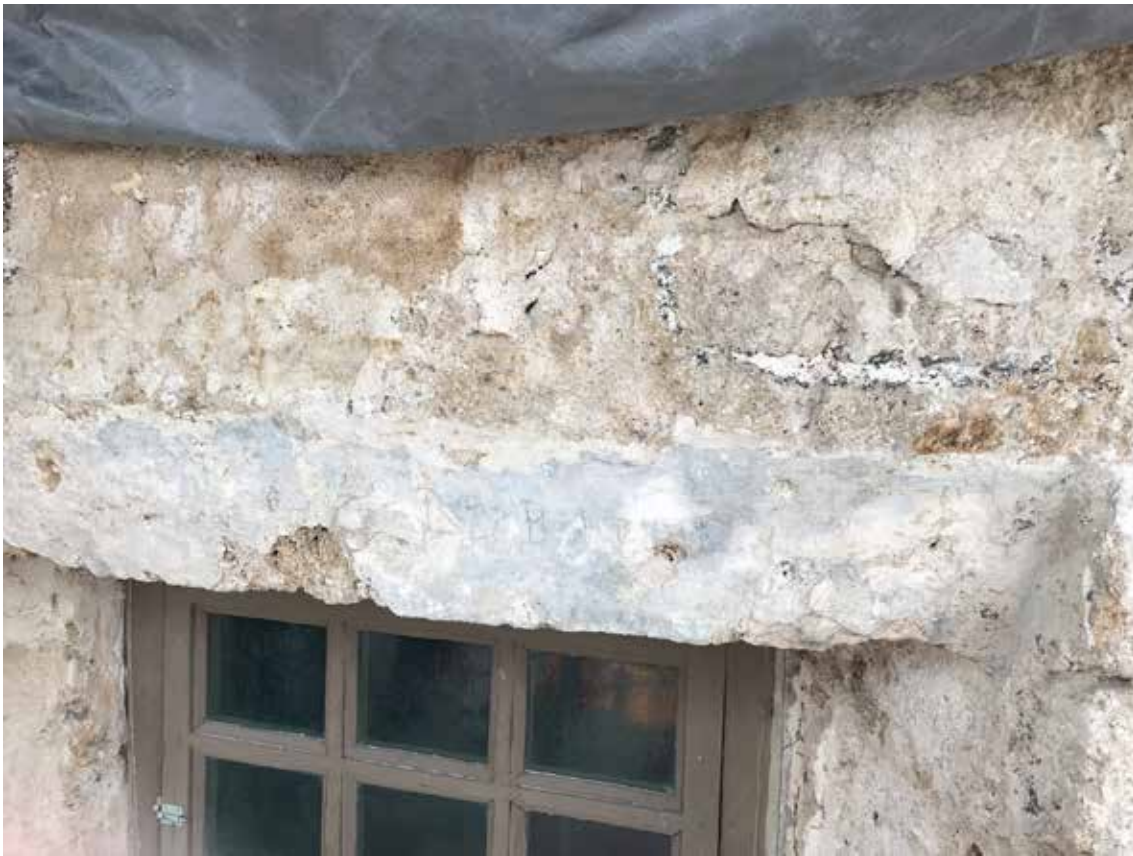
West window at drum, showing area of intact historic Colonial plaster with 19th-century carved graffiti (03.04.2020)

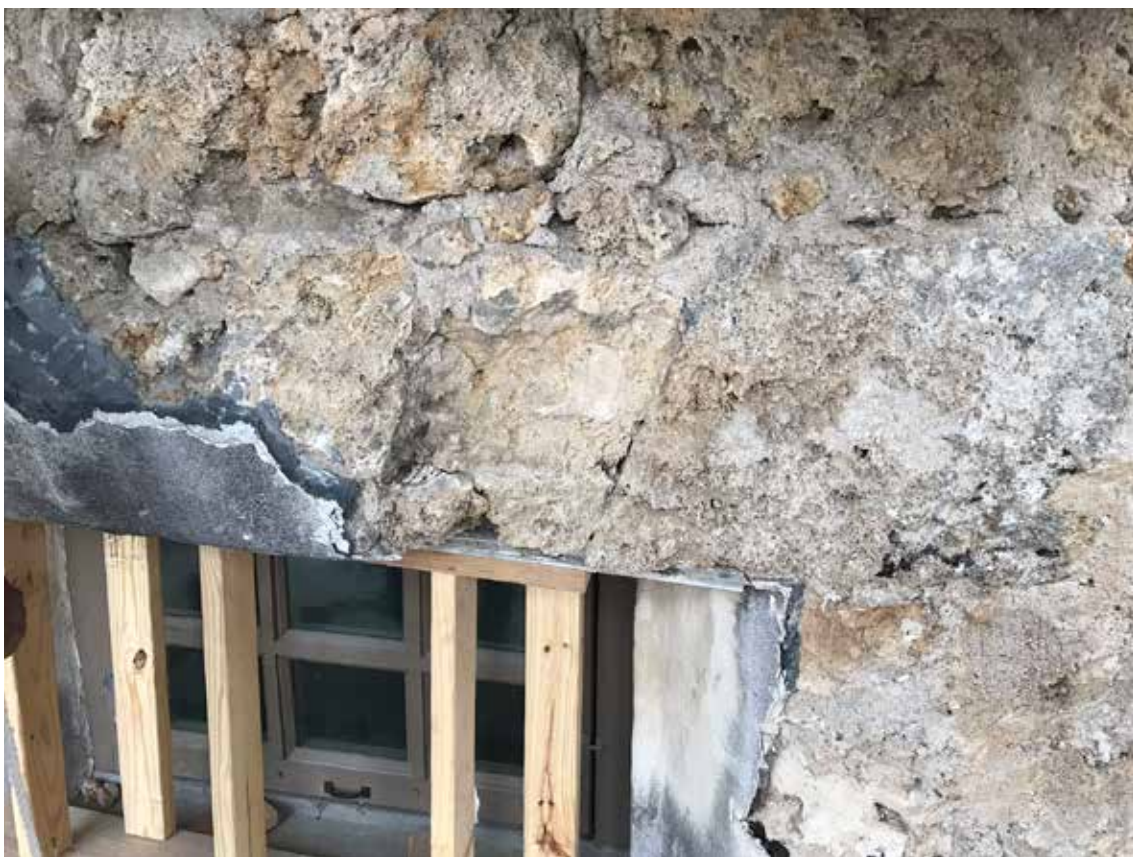
Detail of water damaged mortar and masonry above north window. Hard, dark grey cement (visible at left) from the early 1900s caused moisture to be trapped inside the wall and cause damage. This area has been grouted with mortar and "stitched" with stainless steel rods to strengthen it (03.03.2020)

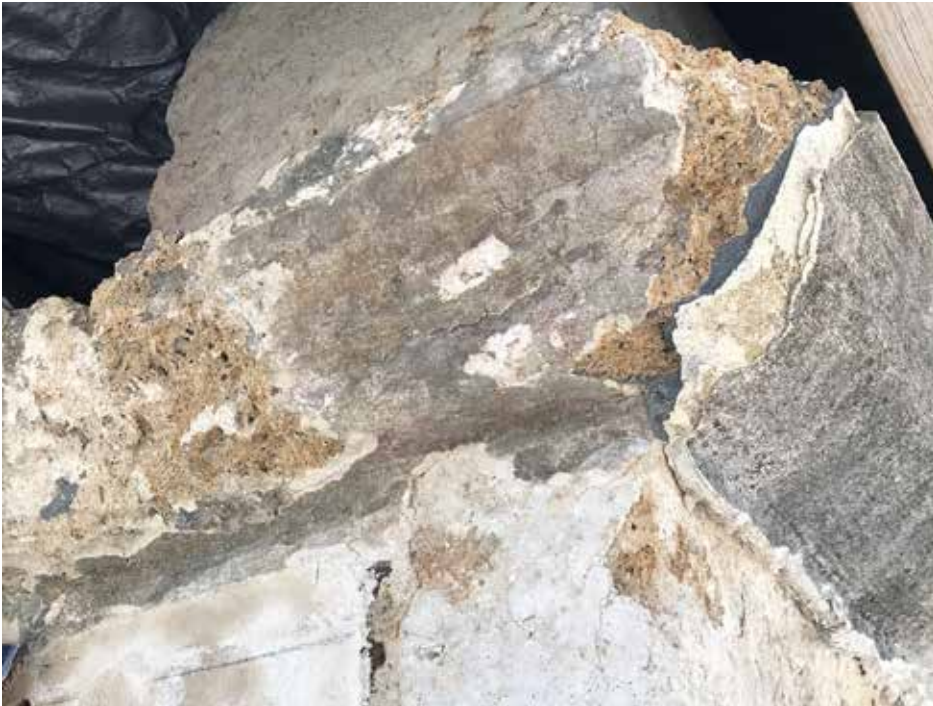
Detail of intact section of historic Colonial plaster at the cornice. This will be used to help us rebuild the historic cornice profile around the perimeter of the dome.
(03.11.2020)

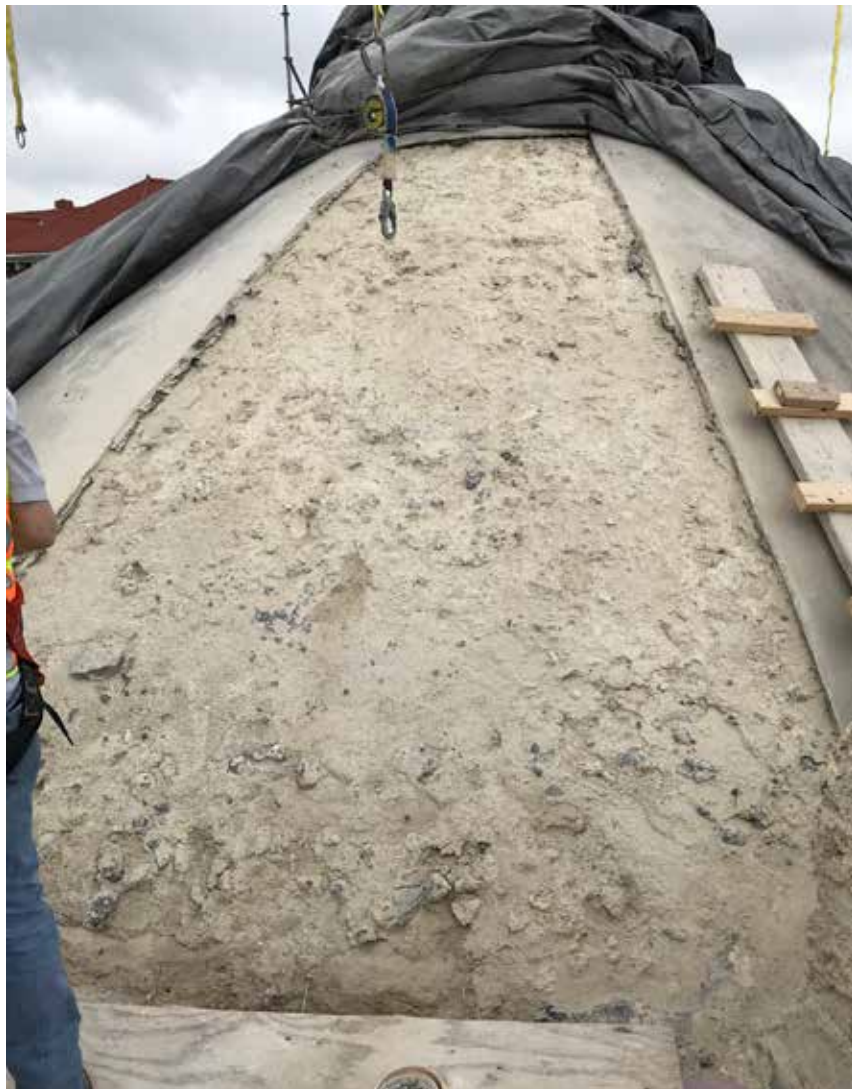
Section of the Dome at the west elevation, after removal of modern roofing materials. This section will receive grout injection and stitching, with stainless steel lath, along the lower 5 feet to help strengthen the stone construction.
(03.17.2020)

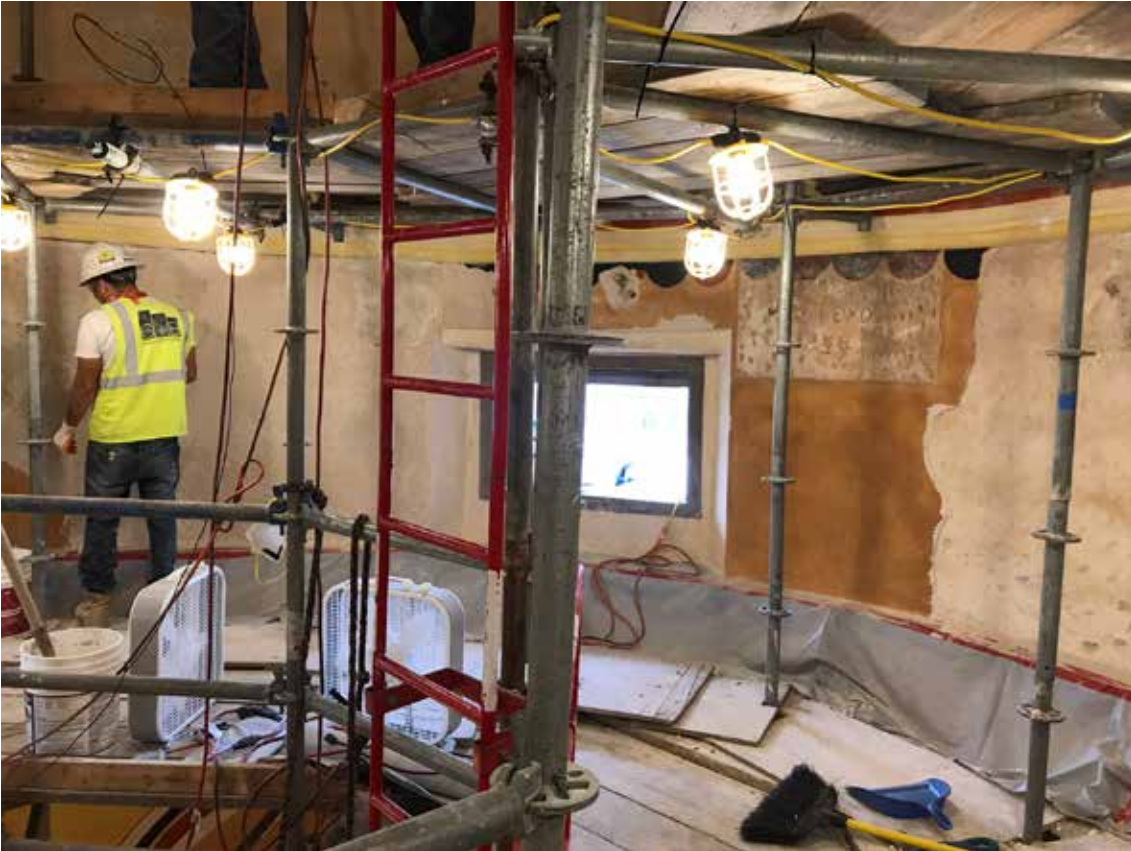
Removal of loose modern plaster at the drum interior (03.16.2020)
